**DUNSCORE PARISH CHURCH**

**CONDITION REPORT**

**THE EXTERIOR FABRIC OF THE CHURCH BUILDING**

**DECEMBER 2014**

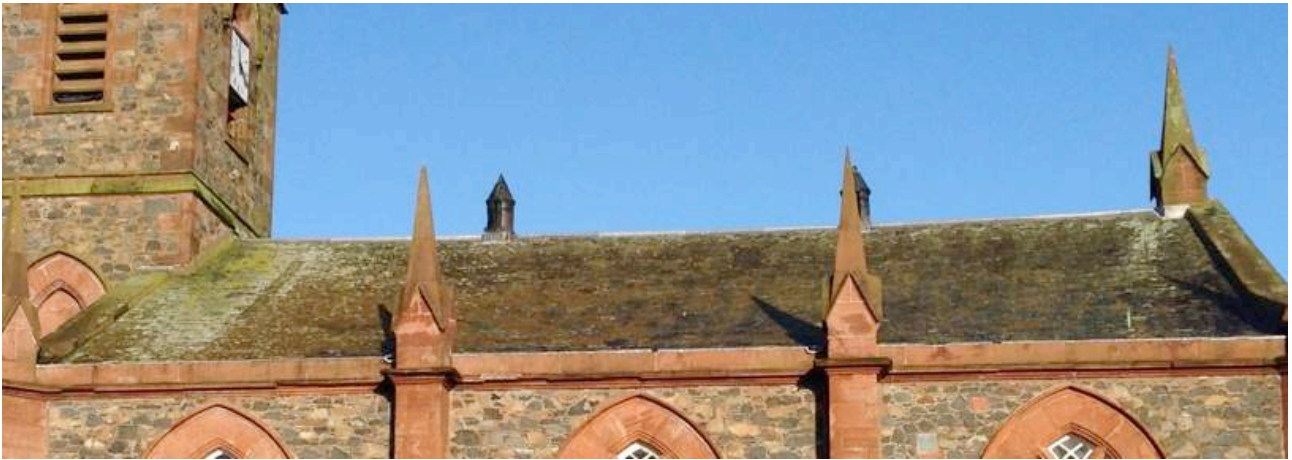
- R1 The main roof is slated with Scotch slate, laid in diminishing courses, this generally appears to be reasonably sound with a few slips and cracked slates, which require refixing. The build up of moss needs to be removed as it retains moisture and causes frost damage to surface of slate and erosion of gable and tower stonework. The north slope is not easy to view from ground level, however it appears to be in considerably better condition than the south which suffers the prevailing south westerly weather from across the countryside.

R1	Refix slipped and uneven slates on roof slopes, and removal of moss	£750
R2&R4	Replacement of abutment flashings of slate roof against tower and skew copes	£2,800
R3	Check and refix lead ridge sections, including replacement piece against tower	£500
R5	Remove vegetation and apply biocide to tower roof and parapet	£500
R5	Replace mortar pointing and sealant of tower roof cover flashings on all sides	£1,200
G1	Clear all gutters and downpipes seasonally and check condition of outlets and lead	£200
S2	Rake out pointing to south and west elevations of tower and repoint	£4,000
S4	Repoint tower roof parapet wall and copes on both sides	£2,000
S9	Rake out defective pointing to 3no. south window tracery and dressings. Indent damaged mullion and transom sections.	£6,600
S9	Rake out defective pointing to West door and window dressings. Check lead dressing details	£500
W2	Conservation repairs of main south elevation timber windows and redecorate	£6,000

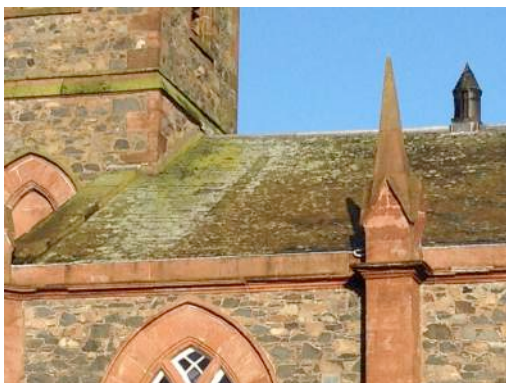
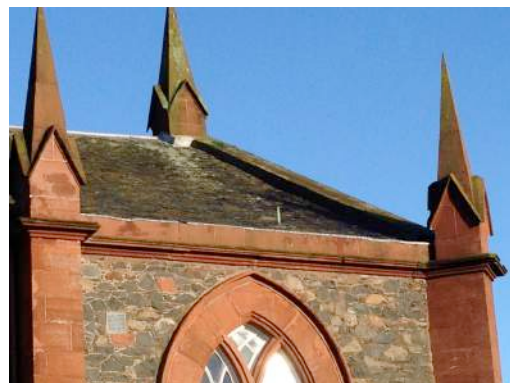
- R2 The south side has extensive weather staining, build up of moss and lichen, unevenness in coursing due to wind disturbance and at the east end there is a sag to the roof and structure which appears to be of long term standing as the abutment cement fillet has been formed to accommodate it. The abutment with the West gable has a low skew cope and concealed leadwork and abutment with the tower has a cement fillet which is aged and decayed. There have been problems with water ingress and repair and replacement of the abutment flashings is recommended in leadwork. It is anticipated that the problems with the existing details has caused some decay to the sarking boards which will also require repair. The cement fillet against the East gable appears to be in a reasonable condition, however water ingress to the gable has caused damage to the plaster due to pointing failure..

R2	Check condition of sarking at skew abutments against tower and gables, localised repairs anticipated	£1,200
R2	Replace cement fillets at skew junctions with lead detail East gable.	£2,500
R5	Check all leadwork laps and joints tower roof	£200
R6	Provide lightning protection system	£3,000
G2	provide rodding access points to base of downpipes and after repairs, re-decorate all rainwater goods	£300
S2	Rake out and repoint defective joints in rubble work localised areas, all elevations	£3,000

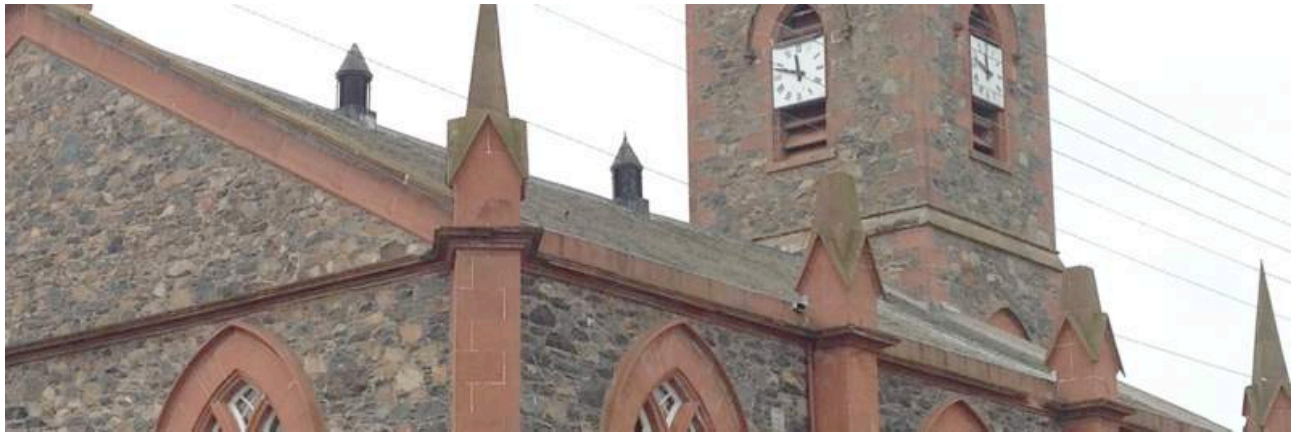
- R3 The ridge appears to be lead and in a reasonably sound condition. There are two metal ventilators on the ridge, modern replacements for original fittings, and these appear to be sound condition. During roofing works a full check on the ridge, fixings and abutments is recommended. The junction at the west end against the tower is suspect as point of water penetration and a short section is likely to require replacement.

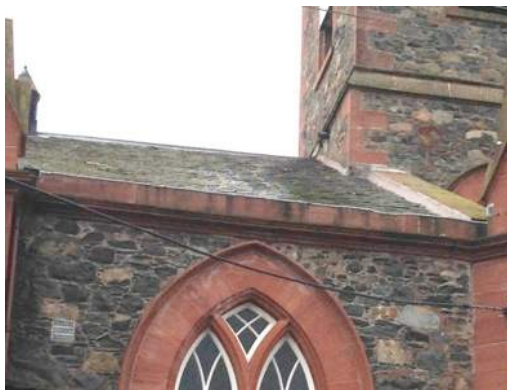
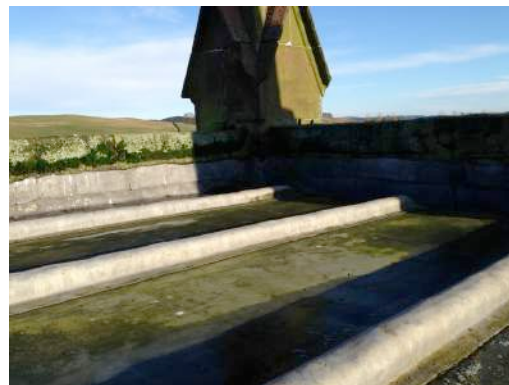
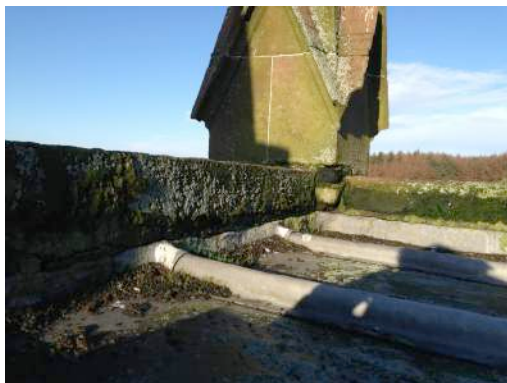
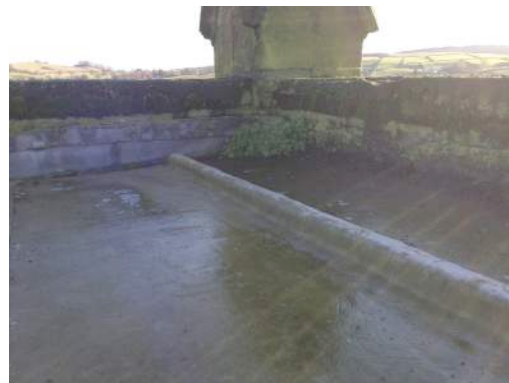
- R4 The North slope of the nave roof is difficult to view however there is less moss, slates are more even and condition of the abutments with the tower and gable skews does not look to be as badly weathered. The cement fillet at the west end has been replaced in recent times, however water penetration at this abutment indicates it is failing and a lead secret gutter detail is recommended.

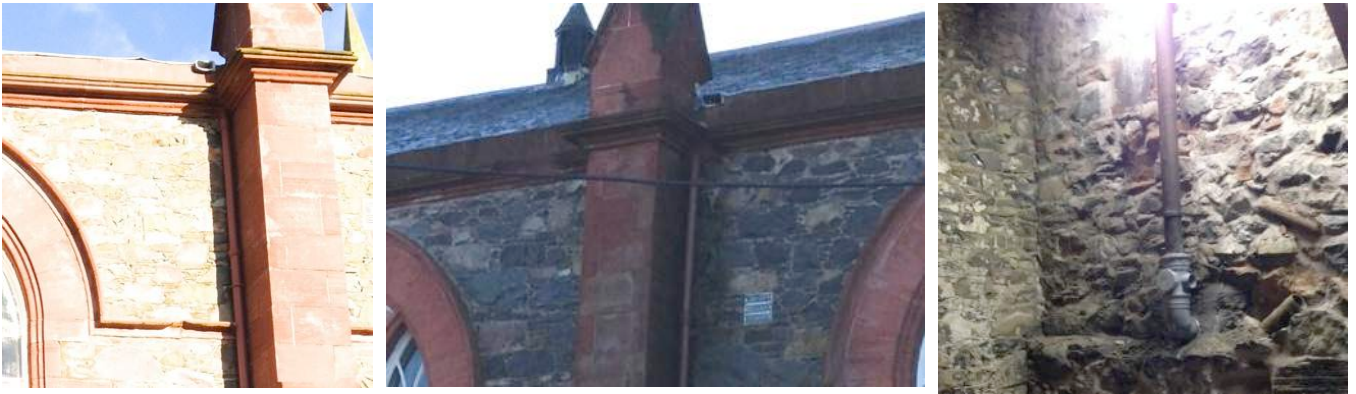
- G2 The two cast iron downpipes on the side elevations are in good decorative condition. They do not have rodding access at the base and connect direct to underground drains which are believed to go to soakaway. The introduction of hand-hole access plates is recommended to help ensure blockages can be cleared.

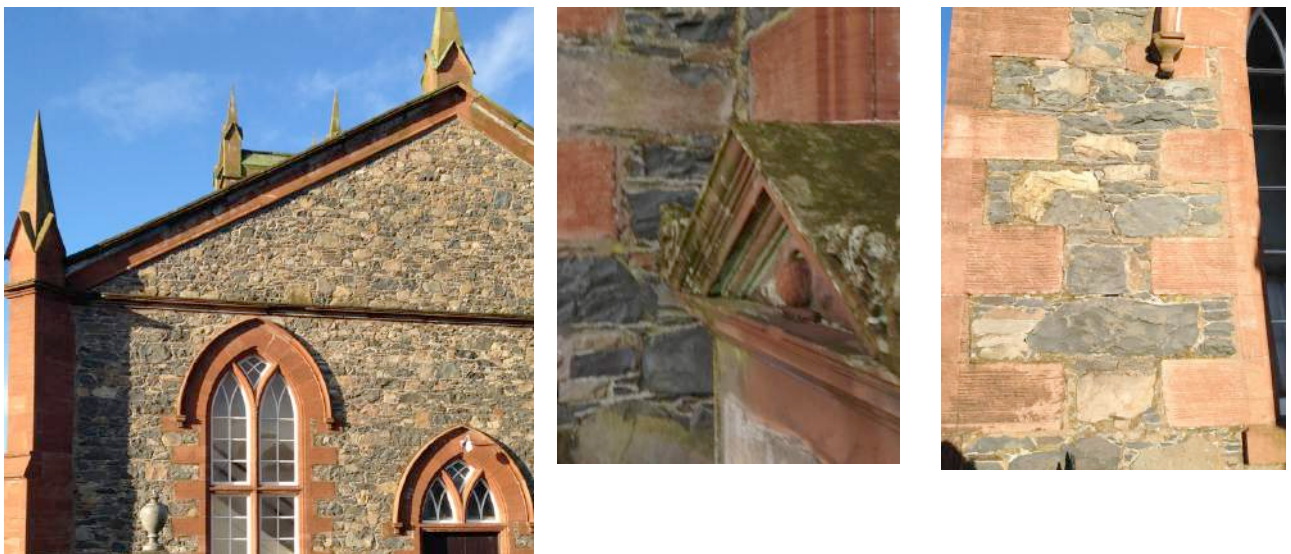
- S1 The masonry walls and tower are generally in reasonable condition, although areas of erosion are noted on the red sandstone dressings. Problems noted as follows.

- S2 The whinstone rubble walls have strong pointing, probably containing a reasonable level of cement, which is suitable for the hard stone. However, there are areas where pointing has fallen out or is cracked and as whin does not absorb water on the exterior surface, moisture is penetrating through these joints and natural hairline fissures to damage the interior finishes. Algae on mortar joints indicates where water penetration is a problem and localised areas on all elevations require repointing with appropriate mortar. Areas to focus on are related to the interior problems with damages decoration and plaster: East gable extensive, around windows on south elevation, south west corner of church, tower south elevation, and around door tower west elevation. High level vents in the masonry assist with venting the cavity behind the plaster and lath and drying the masonry.

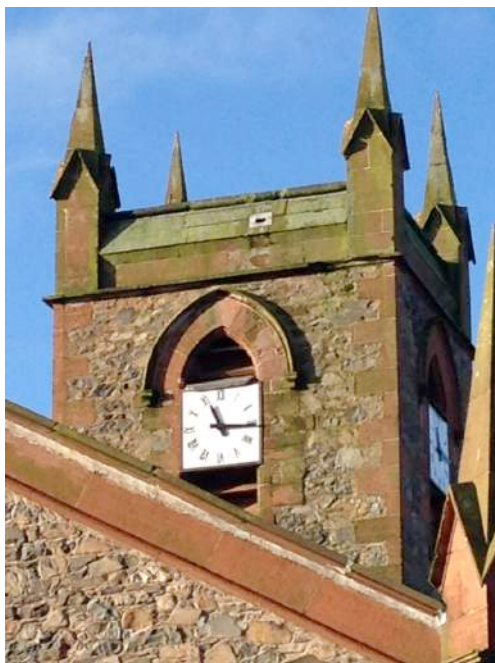
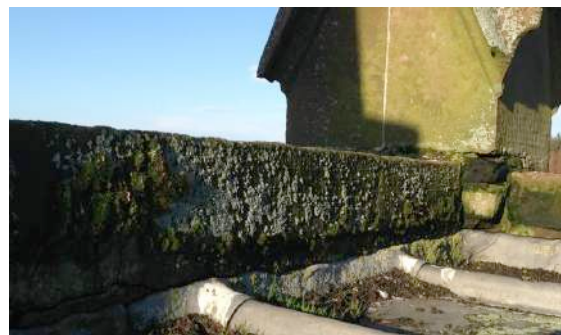
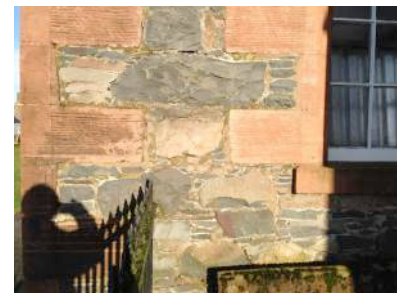
- S3 The red sandstone dressings have areas of erosion and defective pointing is indicated where there is extensive algae due to moisture retention. South and west sides are particularly affected. The sandstone adjacent to whin has to deal with the water run off and absorbs it in a concentrated location. Mixed pointing mortars appear to have been used and careful assessment of suitable lime based mortar is necessary to ensure weathering is not accelerated.

- S4 The tower parapet sandstone stonework has considerable algae and vegetation on copes and flat upper surfaces. Scraping and use of a biocide wash is recommended and then areas of repointing. The inner face of the parapet wall is in particularly poor condition with pointing cracked and missing.

- S5 The pinnacles have been a problem over many years with loss of mortar and bedding, some have had to be re-fixed and several replaced. The majority of pinnacles are currently in sound condition except 2no. on the north side where the top stones have been removed and require re-fixing with ss pins and re-bedding. Each pinnacle should be checked and repointed localised areas as necessary.

S3	Take samples of mortar for analysis for suitable matching of mortars for repointing	£2,000
S5	Refix and repoint pinnacle stones north side and check pointing of all pinnacles	£1,500
S6	Remove vegetation, apply biocide wash and repoint open joints to skews and copes to gables and localised partial indent / lithomex repair to eroded profile for improved weathering	£2,000
S7	Rake out and repoint defective eaves corbel joints in localised areas and carry out necessary stone repairs.	£1,500
S8	Rake out and repoint defective joints in localised areas to buttresses	£500
S9	Rake out localised areas defective pointing to window dressings and hood mouldings	£1,000
F2	Making good plaster and re-decoration repairs in several locations in main sanctuary ceiling and window reveals after roof and window repairs carried out.	£3,000
F4	removal bird droppings and debris by specialist	£250
F5	Re-decorate water damaged plaster and decorations vestry room	£250

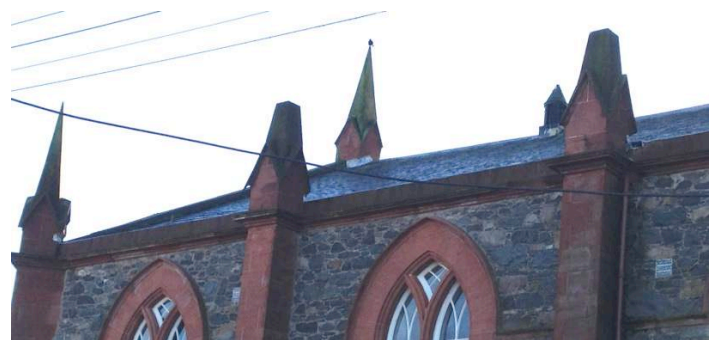
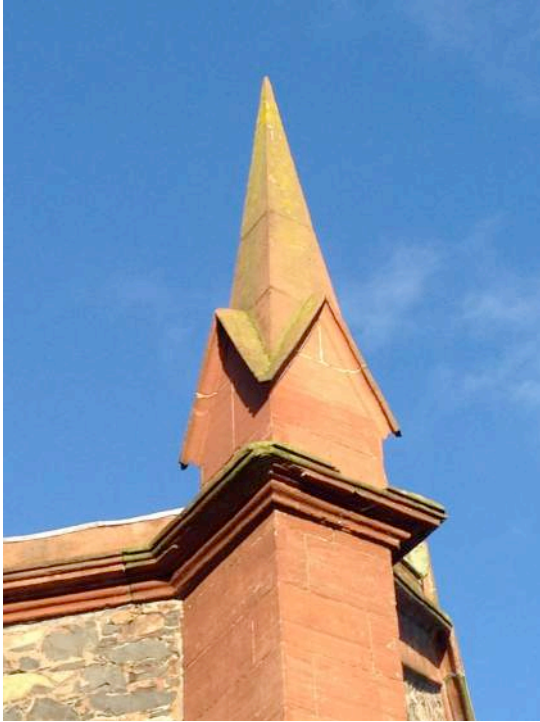
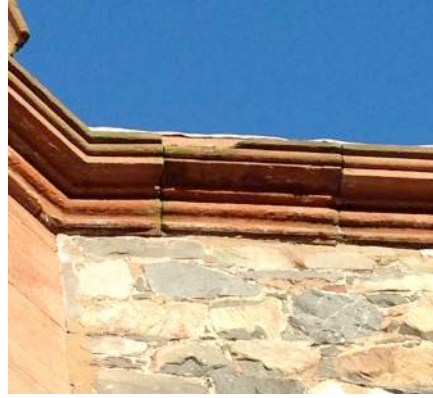
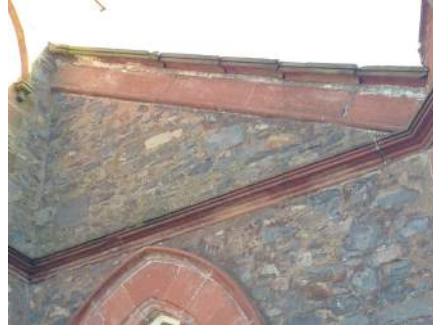
- S6 The skew copes on both gables have vegetation and algae growth and scraping and biocide is recommended followed by repointing. The outer profile has eroded due to extent of weathering, and some pieces broken off. Localised repair with small partial indents or built up Lithomex mortar repair to improve weathering, to be considered.

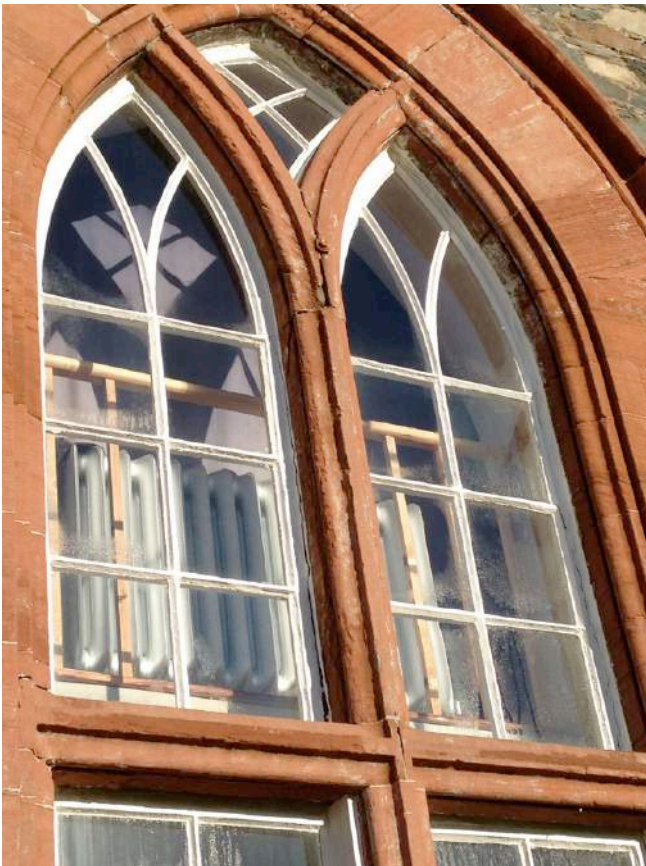
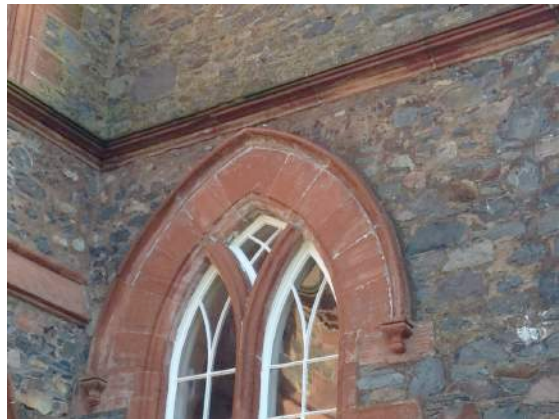
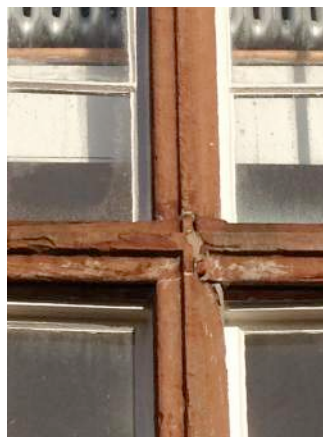
- S7 The sandstone eaves corbel stones and projecting string course have weathered and eroded edges in quite a few locations on all elevations and localised partial indents or built up Lithomex mortar repair to improve weathering, to be considered.
- S8 The buttress stonework on each corner of the church is in reasonable good condition with a few localised areas of missing or decayed pointing, which should be repointed.

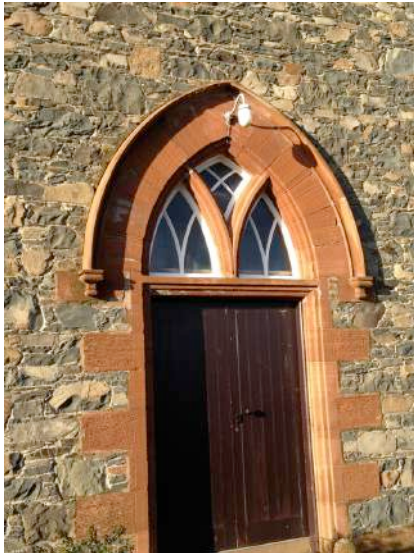
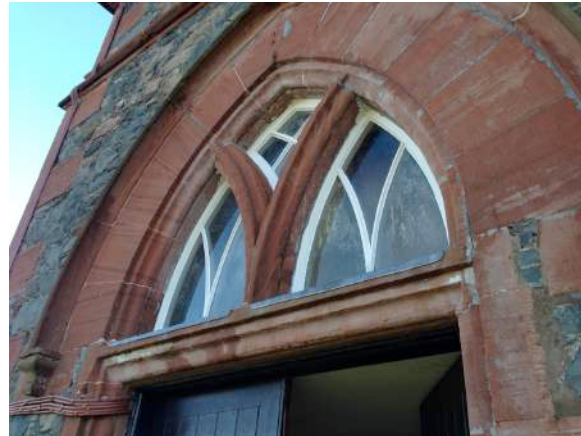
- S9 The window hood mould and dressings are in reasonable condition with a few localised areas of missing or decayed pointing, which should be repointed. However the tracery and mullions of the three south elevation windows are beginning to suffer with erosion, cracks and structural issues at the junction with transoms, and have been pinned on the Y section some time ago. Repair with new ss pinnings and partial indenting is necessary for each window, and full repointing of the dressings. The windows on other elevation are in better condition and only localised repointing would seem to be necessary.
- CS10 The West doors have had long term problems and some lead weather cappings have been introduced to the transom between doors and fanlight. Water penetration continues to be a problem and defective pointing and erosion of the dressings is evident. Repointing of dressings is required.

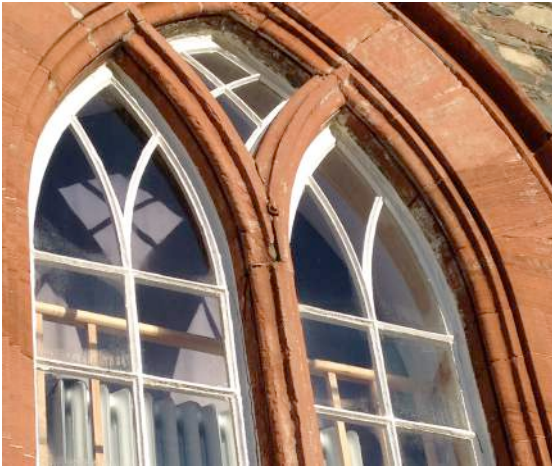
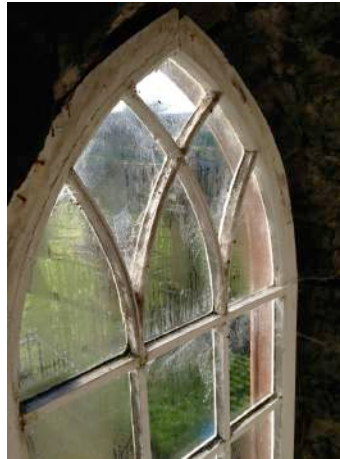
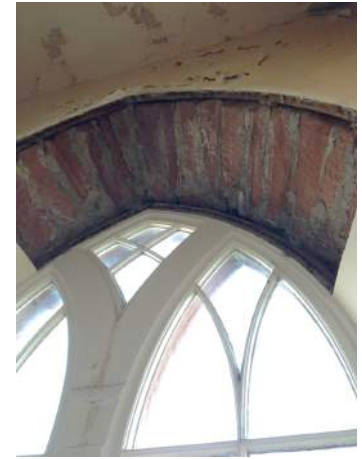
- W1 The windows are all of similar design with timber framed small pane lancets, either in pairs with stone mullions on the main elevations, or single panels on the west elevation. Condition of the stone mullions and transoms are causing problems on the South side in particular. Generally the timber window frames and astragals are in reasonable condition and have been well maintained and decorated to prevent weather decay. However there are some windows where the layers of filler and repair cannot prevent water ingress and localised repair or replacement of frames and cills is necessary.

- W2 The 3no. south elevation windows all have problems with the mastic seals to the jambs and cutting out and repointing in is recommended. To carry out the stone repairs it is likely that windows will need to be removed for access and this will be an opportunity to check the timber condition, refurbish and cut out and piece in repairs as necessary.

- W3 The 3no. north elevation windows do not have the same level of weathering, and condition of decoration is sound.
- W4 The tower windows and fanlight over the west door have suffered with water penetration and decay of the timber is apparent with the tower south window requiring more extensive repair in the frame and cill. Repointing mastic seals is necessary for the windows to the west end .

- W5 Water penetration at the head of the east elevation windows on the stairs to the galleries, has caused plaster damage to the interior, however currently the timber windows themselves are not unduly damaged and localised repair and resealing is recommended along with repair of plaster once water ingress through stonework has been dealt with.

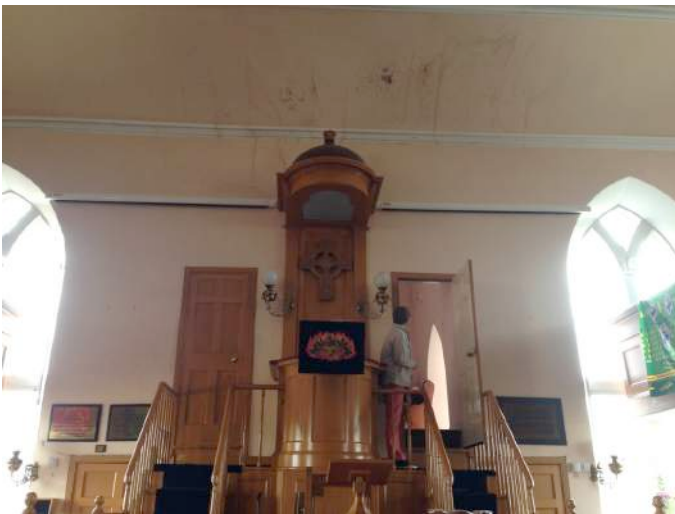
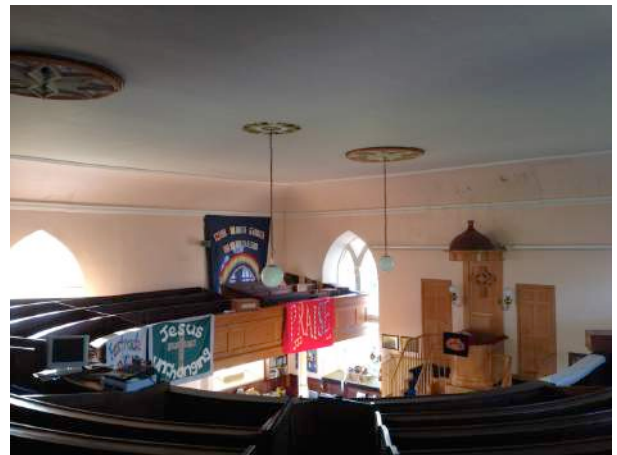
- F1 The interior of the church is in reasonably sound condition, but with several areas of plaster and decoration damaged and affected by water penetration and condensation due to the heavy moisture presence in the structure.
- F2 The plastered ceiling is remarkably free of water damage considering the roof issues, however there is staining and peeling plaster around the perimeter on the coved section, most noticeably above the pulpit where the roof junction with the tower has had water ingress. Patch repairs have been effected but work to the abutment flashings as noted above need to take place for a permanent repair and the damaged plaster of the cove and wall below it can be made good and re-decorated. It may be necessary to carry out patch repair of the plaster if found to be bossed or live.

- F3 There is limited access into the ceiling / roof space from stair landing, which is not safe for access/ Provision of a hatch over the gallery would be very beneficial for maintenance checks on the roof and structure and potential for laying an insulation quilt into the loft space. A high level timber specialist survey is recommended to check areas of roof that have regular water ingress problems.

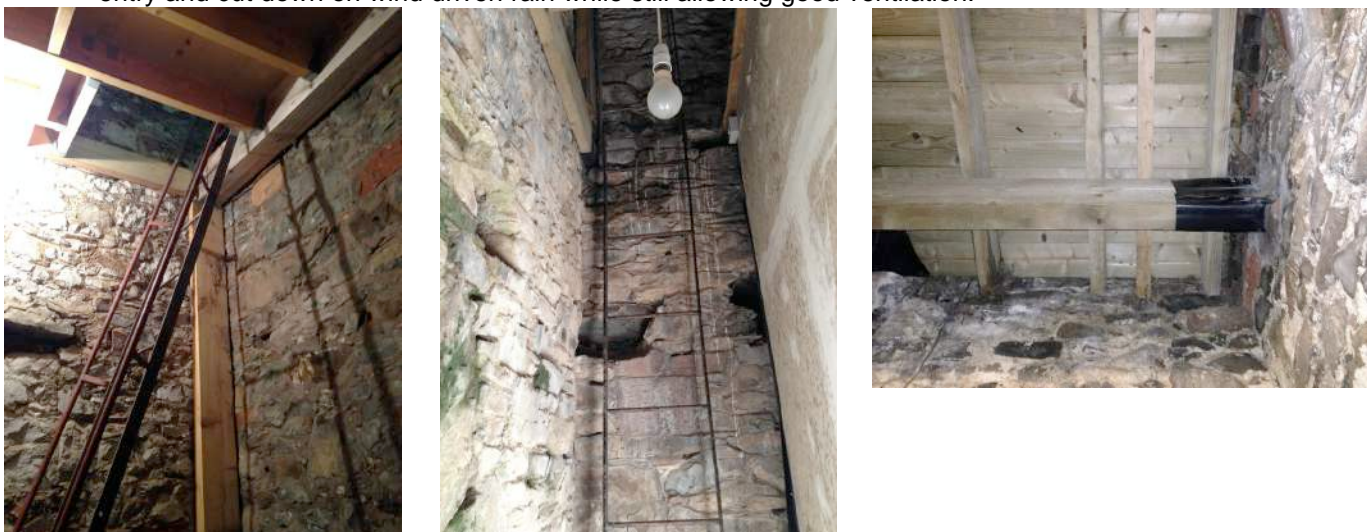
- F4 The tower has had on-going problems with water ingress as can be seen in the staining of the stonework. There are 3no. floor levels within the tower each accessed by fixed ladders. Floor and roof timbers have been replaced and are in sound condition and have protective dpc sheets and treated timber used. Wall conditions have high moisture content, but are not wet except the lower level on the South side which has green algae on the stonework. The tower is reasonably well ventilated due to the stone louvres in the bell chamber which have timber baffle boards to reduce wind driven rain entry. The openings also have wire mesh to prevent bird entry. The use of a more

robust weather mesh should be considered, such as Galebreaker fabric, which would prevent bird entry and cut down on wind driven rain while still allowing good ventilation.

F3	provide new access hatch in ceiling of gallery for safer access to maintenance of roof structure	£500
F4	Provide Galebreaker fabric to inside of louvres	£500
F9 - 10	Reordering options to be developed and considered - to budget	<u>say £30K</u>
	SUB-TOTAL	£31,000

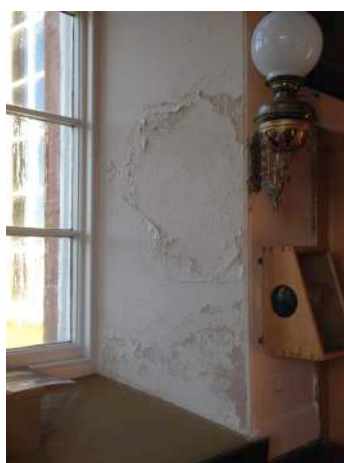
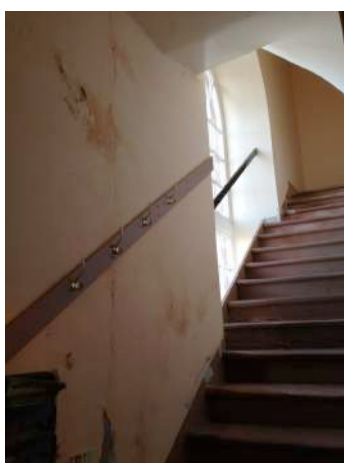
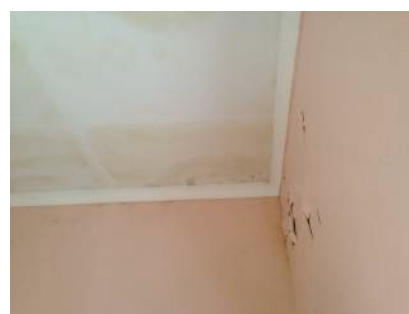
F5 The vestry room in the lower part of the tower, accessed from the pulpit, has damaged decoration and plaster caused by water penetration in the tower and also with poor ventilation and minimal heating. Environmental improvement with more regular ventilation and heating would improve the conditions before re-decorating.

F6 The west entrance lobby area has water damaged plaster and decoration related to the problems with stonework and around windows. Intermittent heating contributes to the issues with condensation.

F7 The extent of water penetration on the east elevation has caused considerable damage to the decoration and plaster of the stairs wall to the gallery. Plaster repairs required once water ingress problems are resolved. As with the west entrance, the intermittent heating and high moisture content of the fabric contributes to the condensation risks. Positive ventilation introduced to the area would be beneficial.

F6	making good plaster and re-decoration repairs inside west lobby and doors	£250
F7	making good plaster and re-decoration repairs inside east gable and around windows	<u>£3,000</u>
	SUB-TOTAL	£25,450

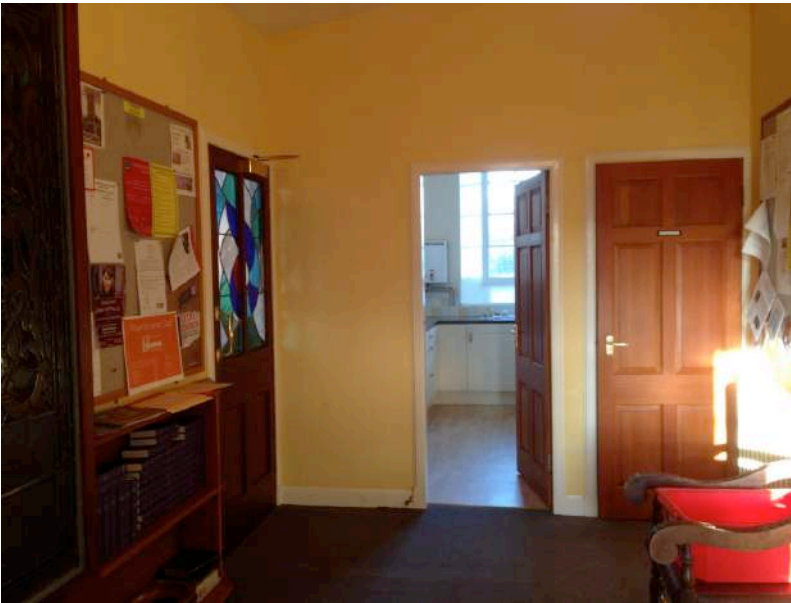
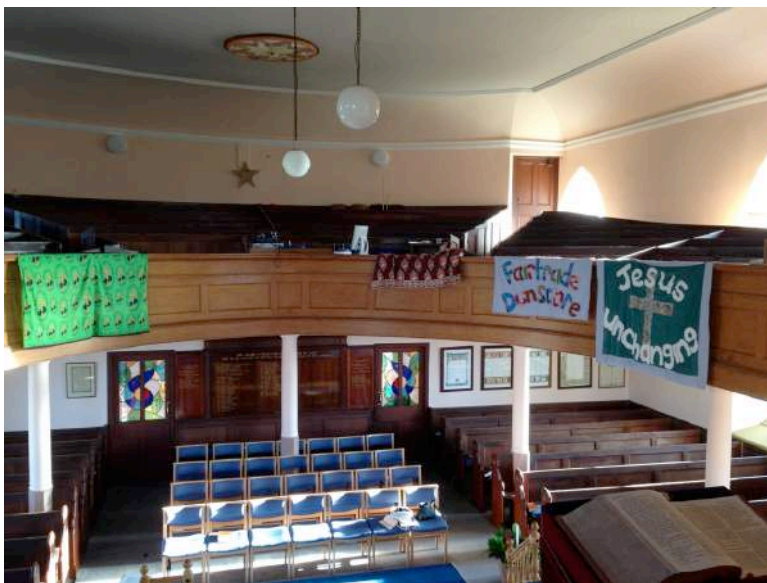
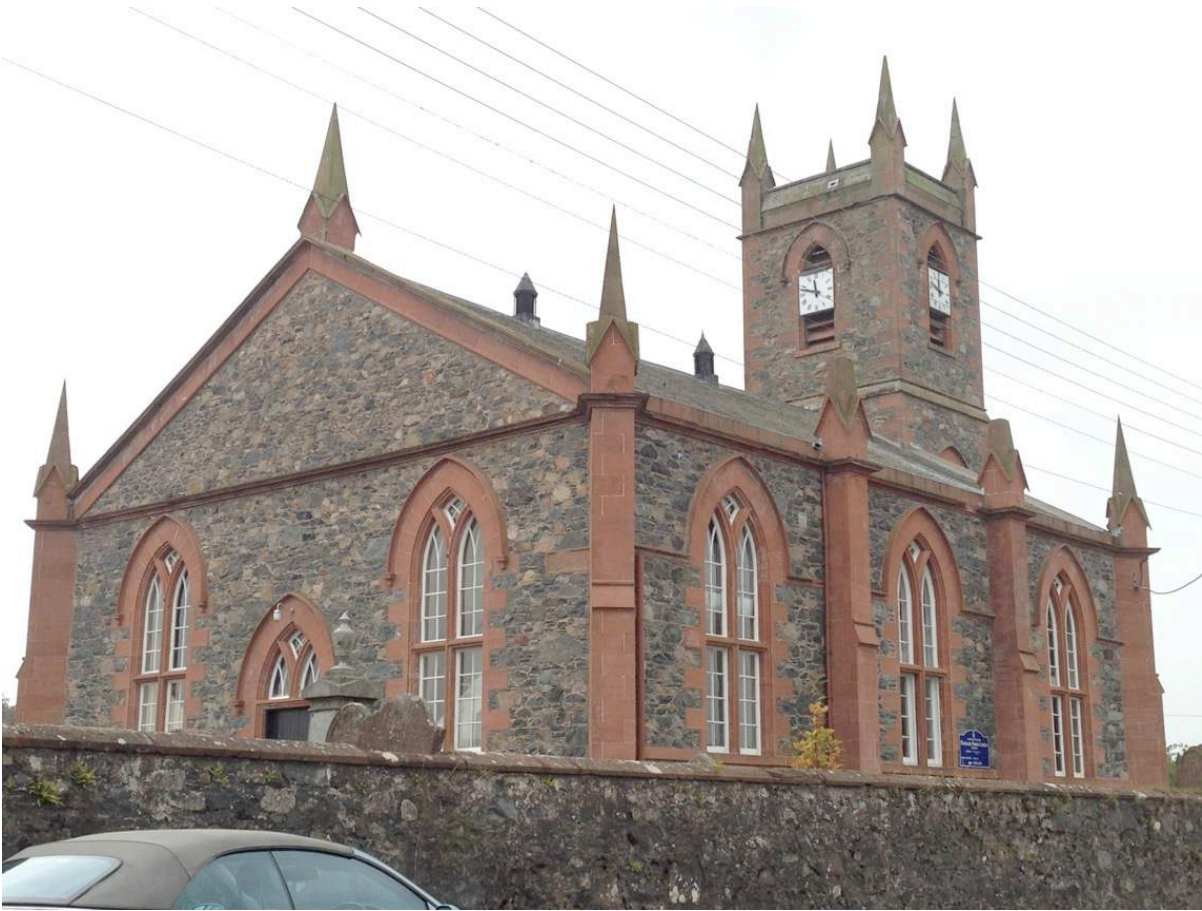
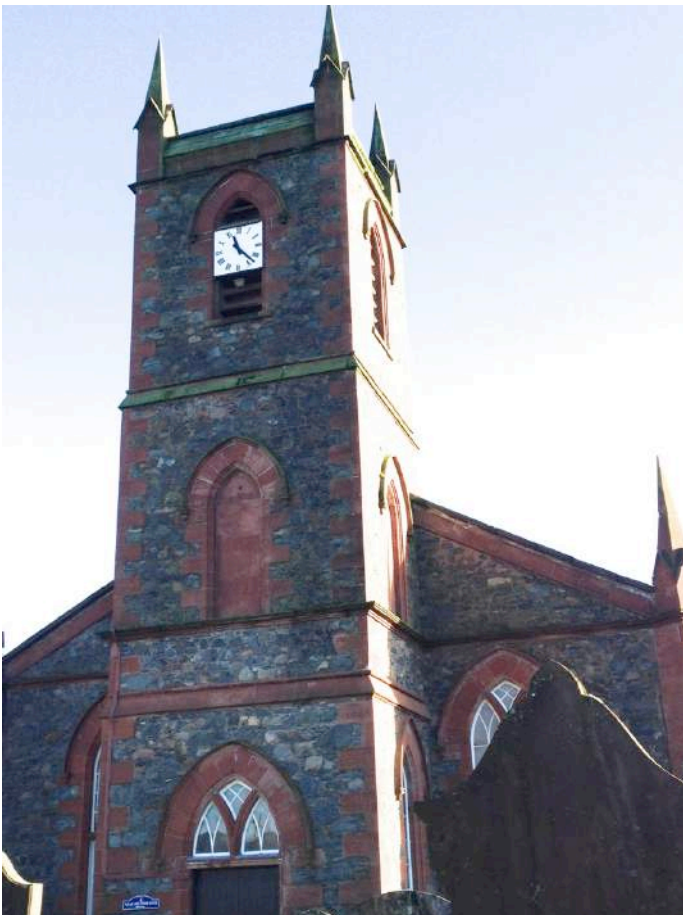
F9 The structure of the gallery is in sound condition, and the pews and front panel joinery are in good condition. Likewise the pulpit and chancel furnishings are in sound condition. The church are considering some re-ordering of the sanctuary to accommodate more flexible worship and to provide exhibition and community activities within the space. Alteration of chancel and removal of pews to be considered.

- F10 The condition of the meeting room and foyer is good and the kitchen has been refitted recently and in good condition. The toilet is tucked into the corner of the building under the stair and although reasonably spacious does not comply with requirements for an accessible toilet suitable for disability use. Improvement to the facilities to be considered as part of the re-ordering design work. The condition of the toilet is reasonable but due to the intermittent heating of the space on the coldest corner of the building, there are condensation issues.
- F11 An asbestos survey and production of a property register will be necessary before any repair or alteration works take place.
